NUBANUSIT LAKE DAM

NH 00339

PHASE I INSPECTION REPORT NATIONAL DAM INSPECTION PROGRAM

AUGUST 1978

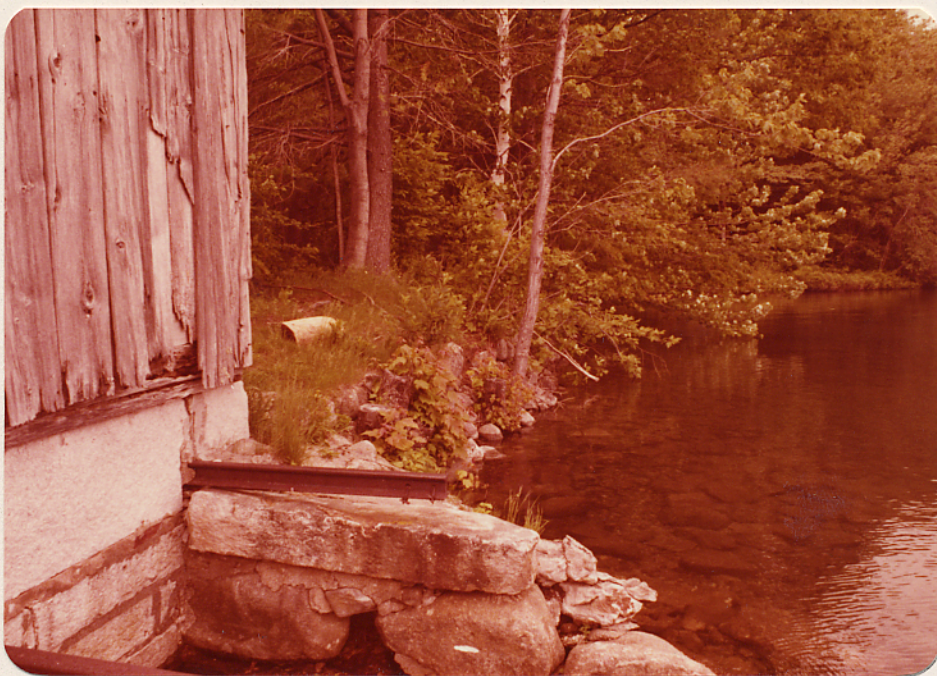
Overview of right side of dam from gatehouse

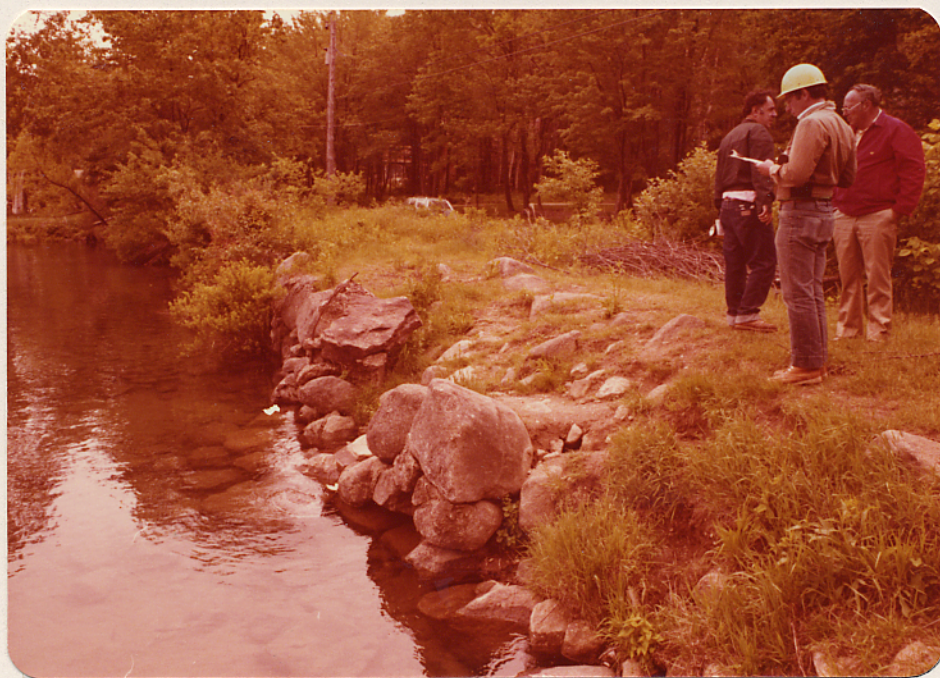
Overview of left side of dam from gatehouse

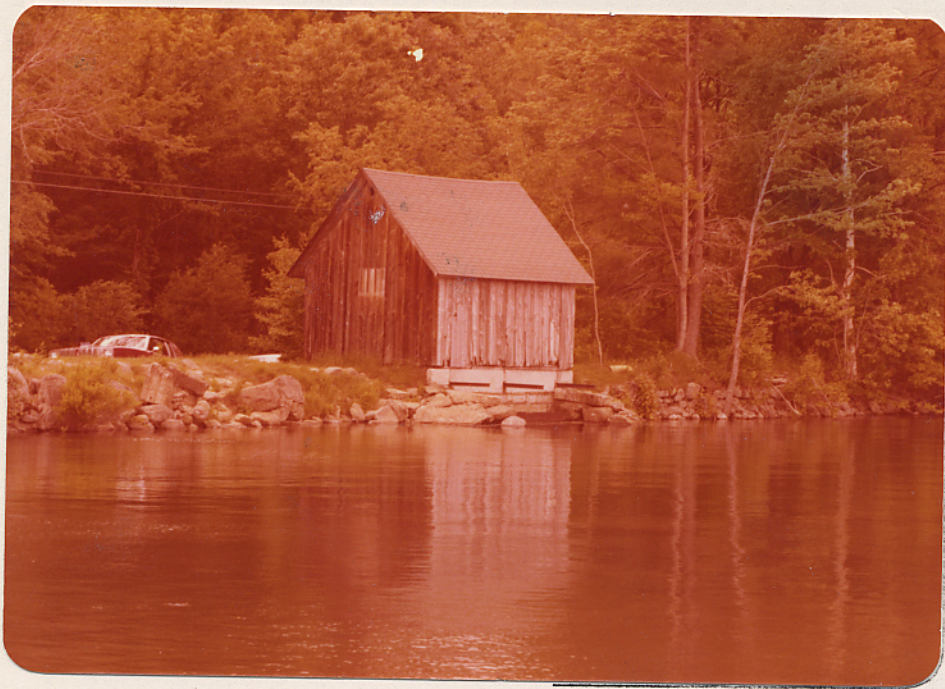
Overview of gatehouse near center of dam from upstream

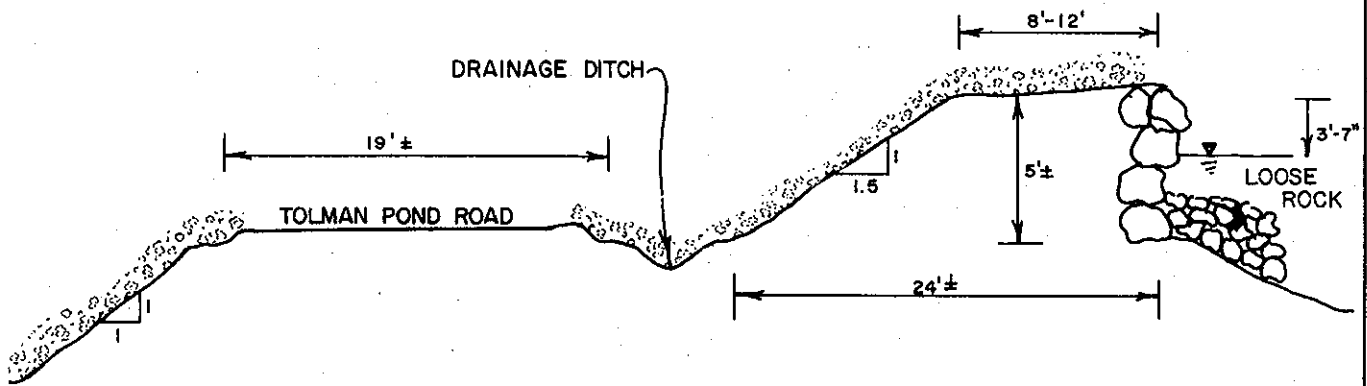
SECTION A-A'
SCALE: 1"=10'

NOTE: WATER LEVEL MEASURED
14 JUNE 78.

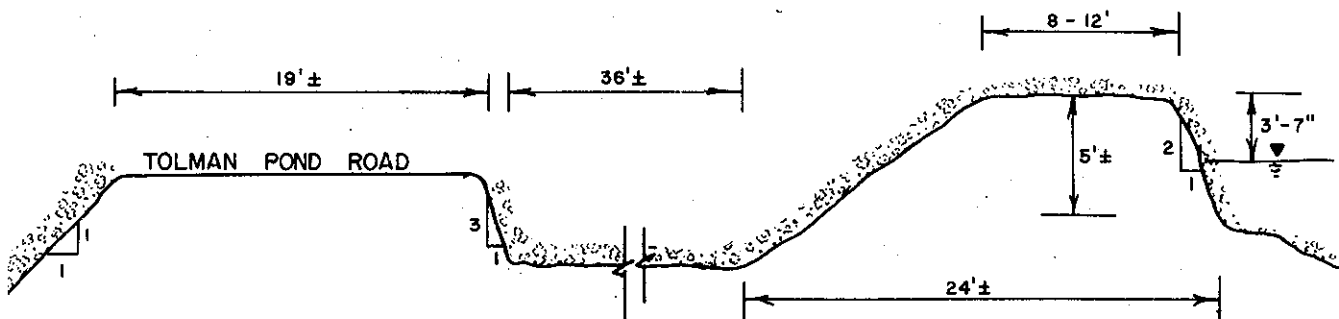
SECTION B-B'
SCALE: 1"=10'

NOTE: WATER LEVEL MEASURED
14 JUNE 78.

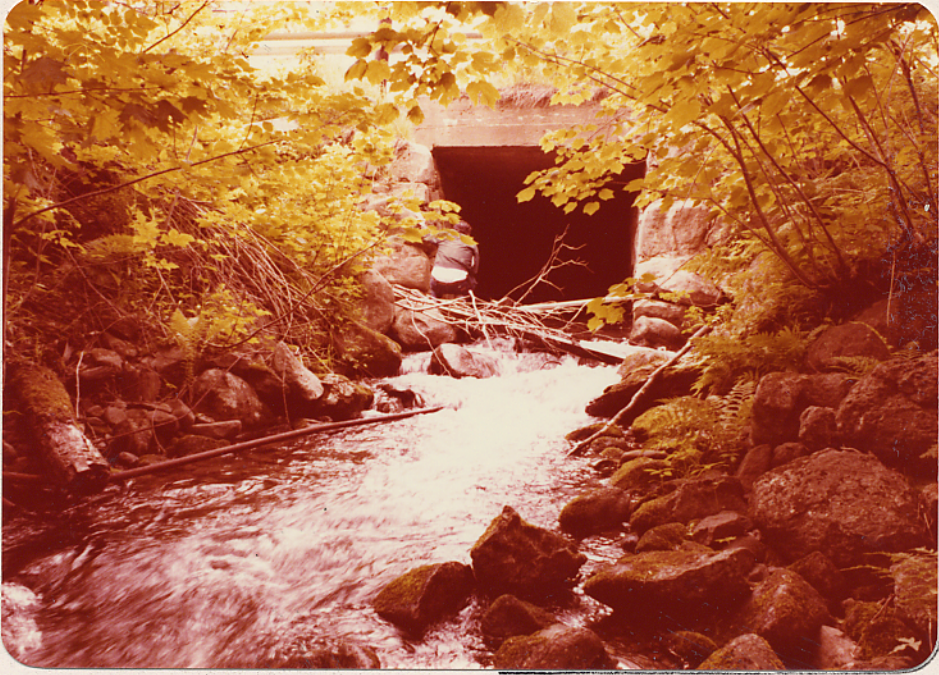
1. View of outlet area and downstream channel

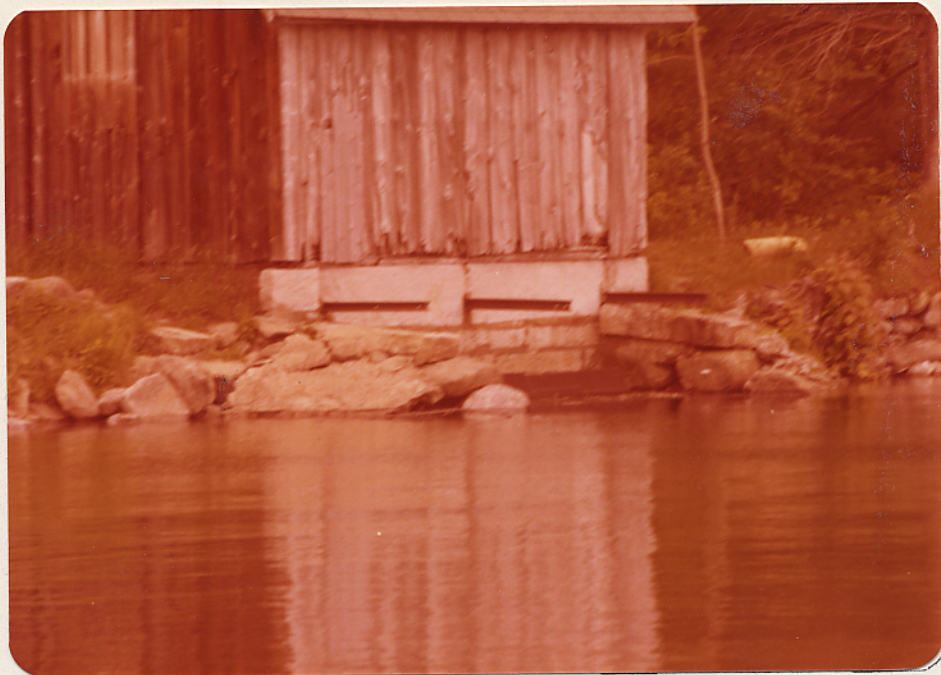
The trash rack upstream of the gate house waterway opening, although slightly rusted, is in good condition. The concrete wingwalls on either side of the trash rack are badly deteriorated with open joints and dislodged stones.

2. Detail of gatehouse inlet from upstream

- (3) Repair the deterioration to the upstream wing-walls by resetting all stones and mortaring all joints.
- (4) Remove all trees and brush from the embankments. Consultations should first be held with forestry experts on the implications to the dam of removing mature trees over 3 inches in diameter.

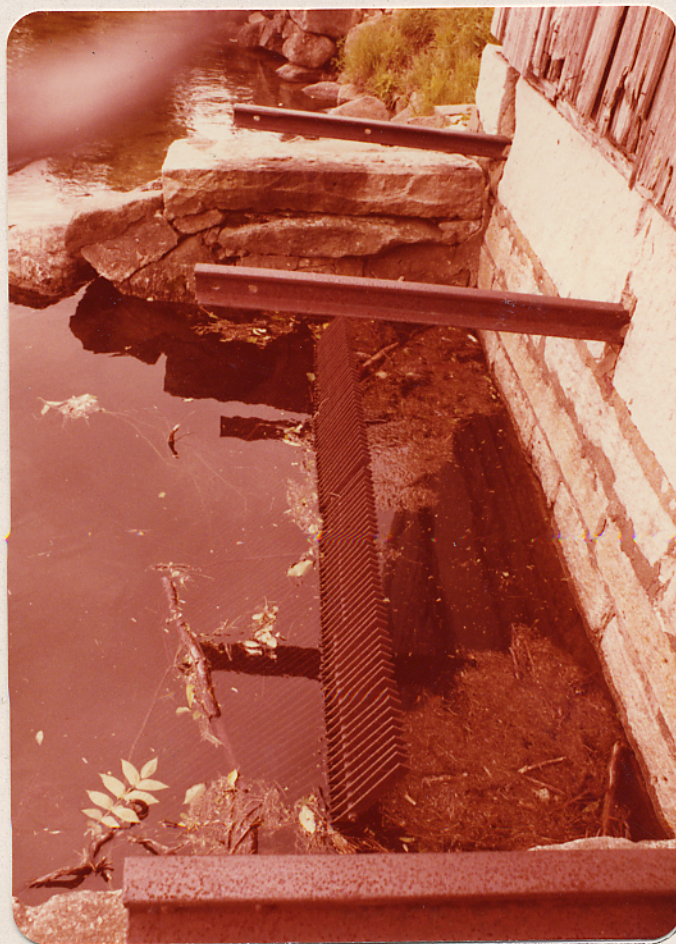
3. Detail of photo 1 from right side of gatehouse
